To: Bradley.Arnold@sumtercountyfl.gov
Subject: FDOT Safety Projects - CR 466 at Belvedere Blvd, Buena Vista Blvd, and Morse Blvd
Attachments: 18000 CR 466 at Belvedere Blvd Final.pdf; 18000 CR 466 at Buena Vista Blvd final.pdf; 18000 CR 466 at Morse Blvd Revised Final.pdf

CR 466 at CR 101/Belvedere Boulevard

STUDY 6C/6E
SUMTER COUNTY

Districtwide Community Traffic Safety Program C-8T80
Financial Project No. 237995-1-32-09
Letter of Authorization No. 6C/6E
FDA No. 01038206C, 01038206E

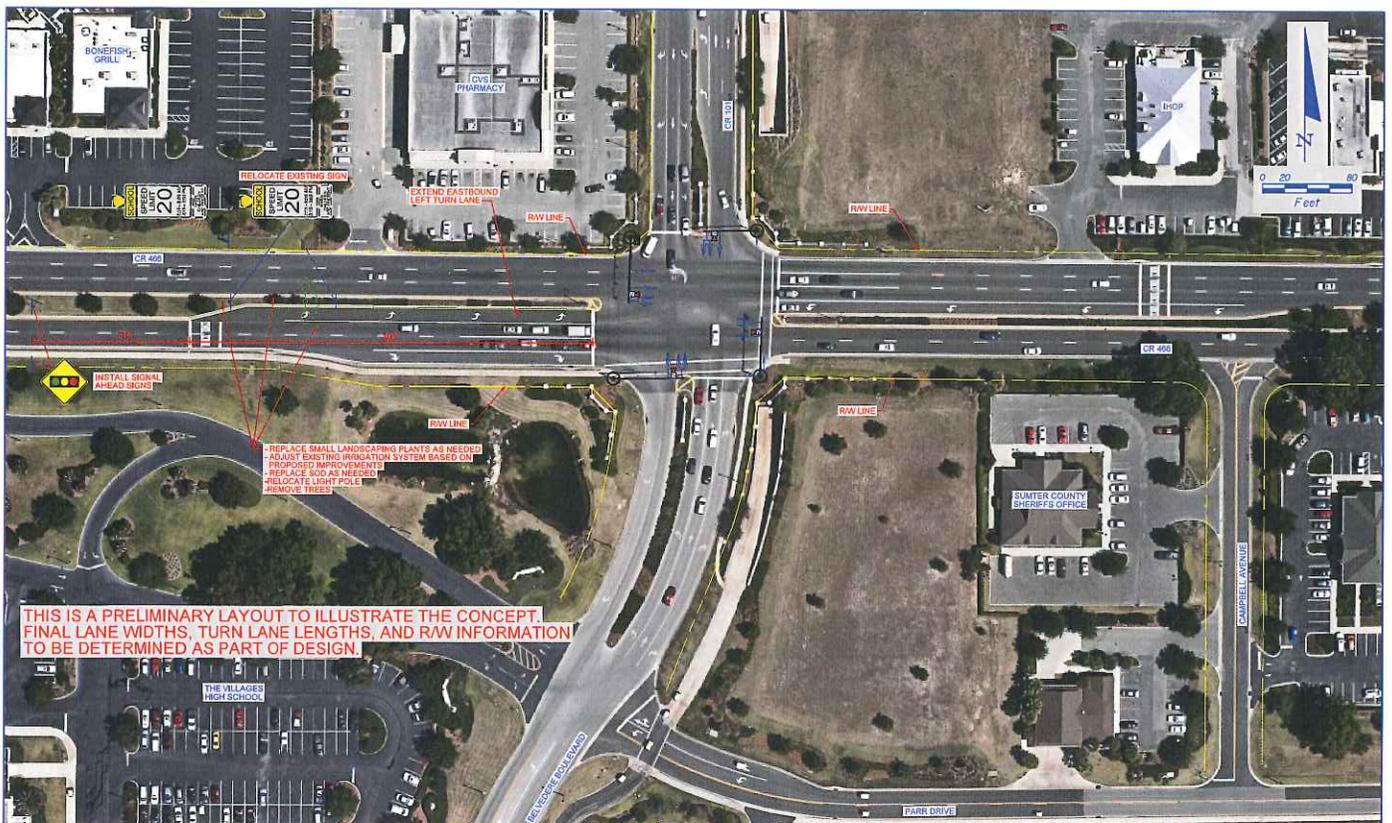
- The eastbound left turn lane should be extended to alleviate the trend of eastbound rear end collisions that are occurring in the inside through lane. The scope of this improvement is as follows:
 1. Relocate decorative street light in the median.
 2. Replace landscaping as necessary.
 3. Modify existing irrigation as necessary.
 4. Replace sod as needed.
 5. No right-of-way impacts are anticipated.
- Signal ahead warning signs should be installed.
- Sumter County should consider providing additional split time to the side street to reduce the observed phase failures during school dismissal.

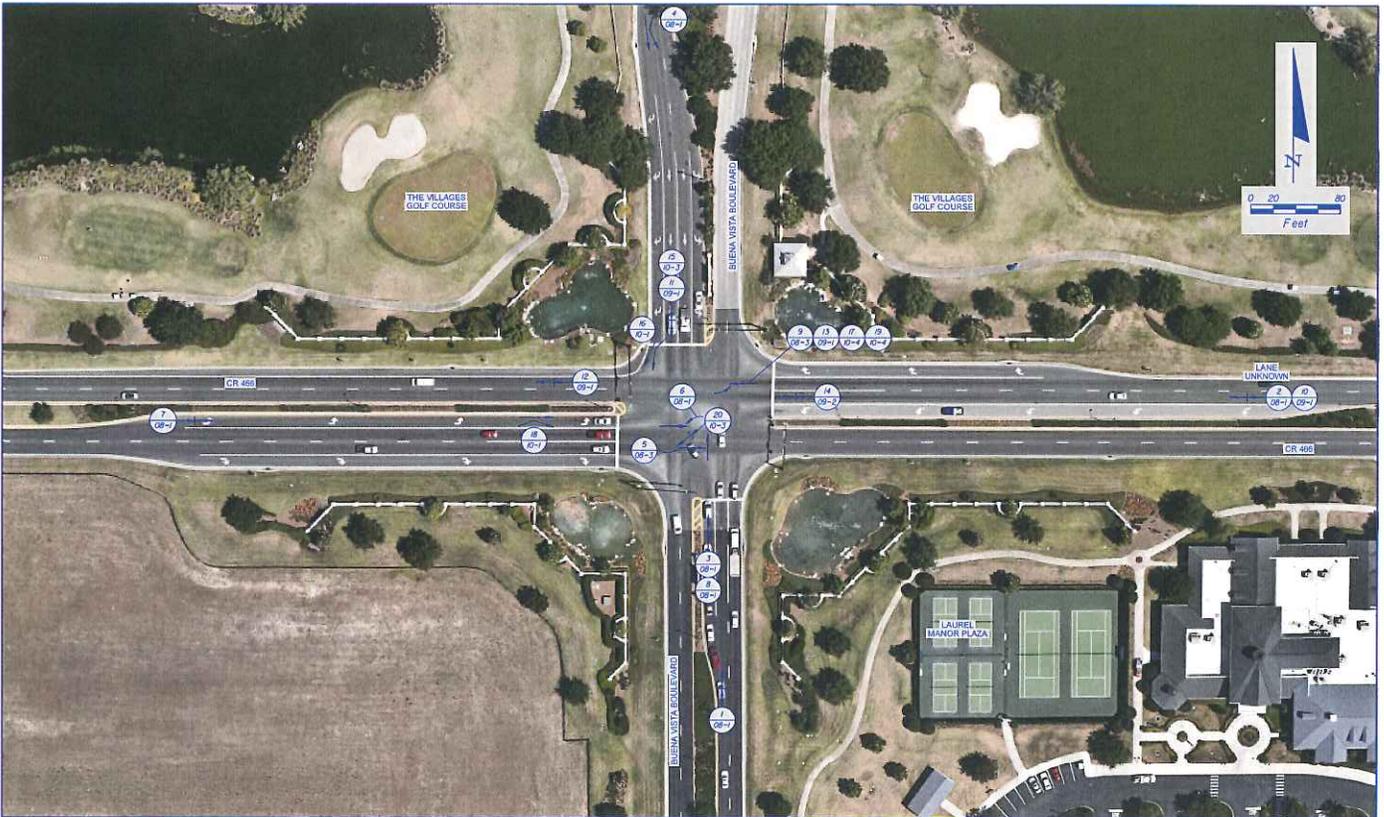
COLLISION DIAGRAM DISTRICTWIDE COMMUNITY TRAFFIC SAFETY PROGRAM		PAGE NO. 12
<i>Fallon Davis & Associates, Inc.</i>

- Crash reports were provided for CR 466 at Buena Vista Boulevard by the Department for the 37 month period ending December 31, 2010. Twenty crashes were reported, which included eleven rear end crashes, five left turn crashes, three sideswipe crashes, and one angle crash. These crashes resulted in 13 injuries, no fatalities, and an estimated \$106,600 in property damage. Approximately 85 percent of the crashes occurred on a dry roadway surface in daylight lighting conditions.

- Four of the five left turn collisions involved eastbound left turning vehicles versus westbound through vehicles. Eight injuries resulted from these crashes; three injuries were incapacitating. The remaining left turn collision involved a westbound left turning vehicle and an eastbound through vehicle. No injuries were reported from the collision. These crashes are potentially related to the sight distance issue noted earlier in the report.

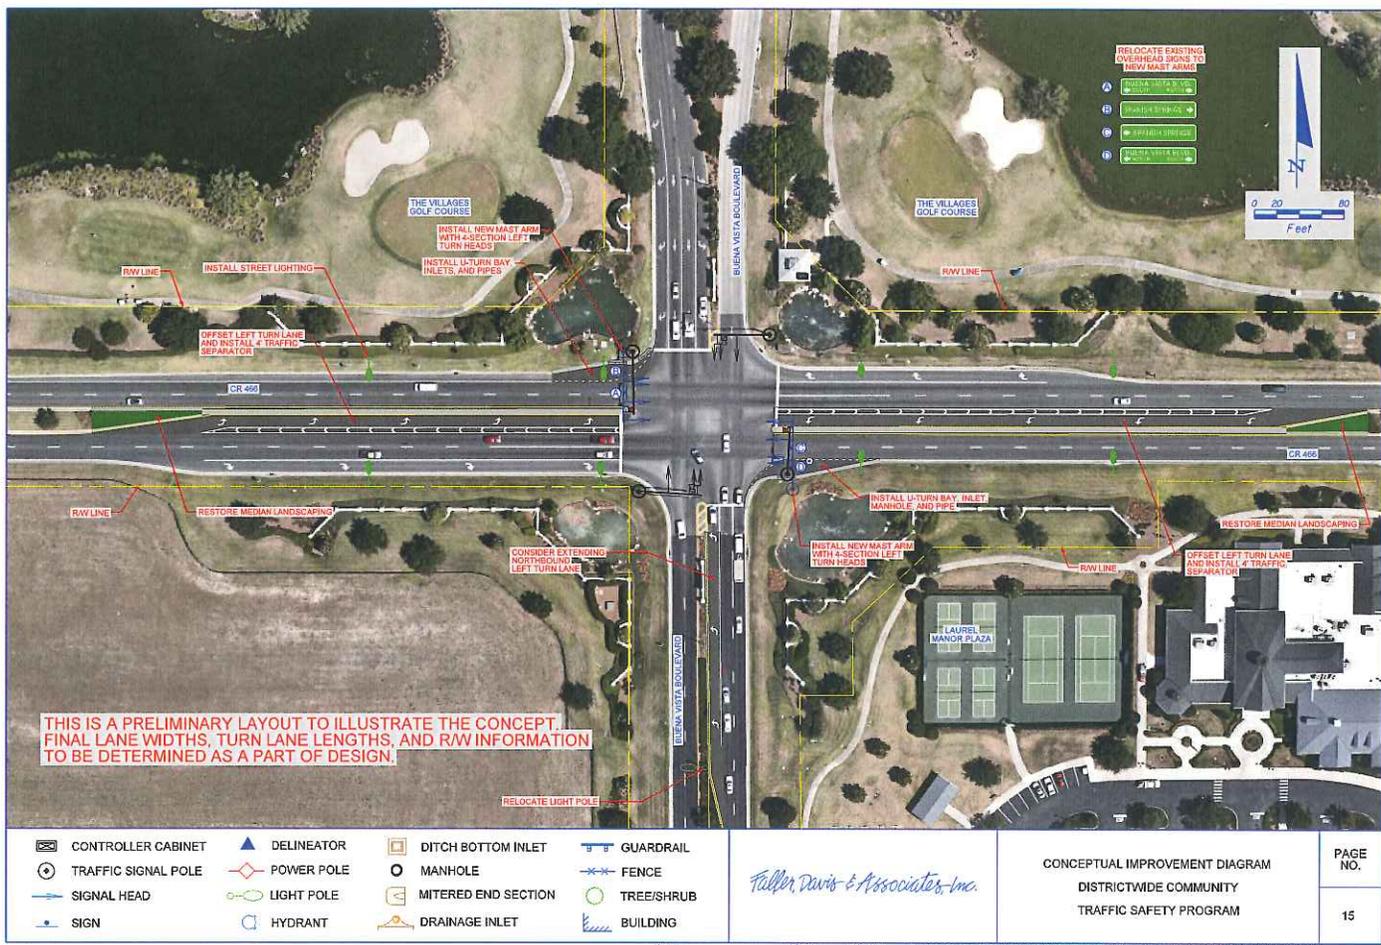
- The mainline left turn lanes are negatively offset from one another, which limits the sight distance when the lanes are occupied by vehicles.
- During both review periods several instances of the following were observed:

Provide positive offset mainline left turn lanes to reduce the incidence of left turn collisions and extend the northbound left turn lane to reduce the observed queuing.

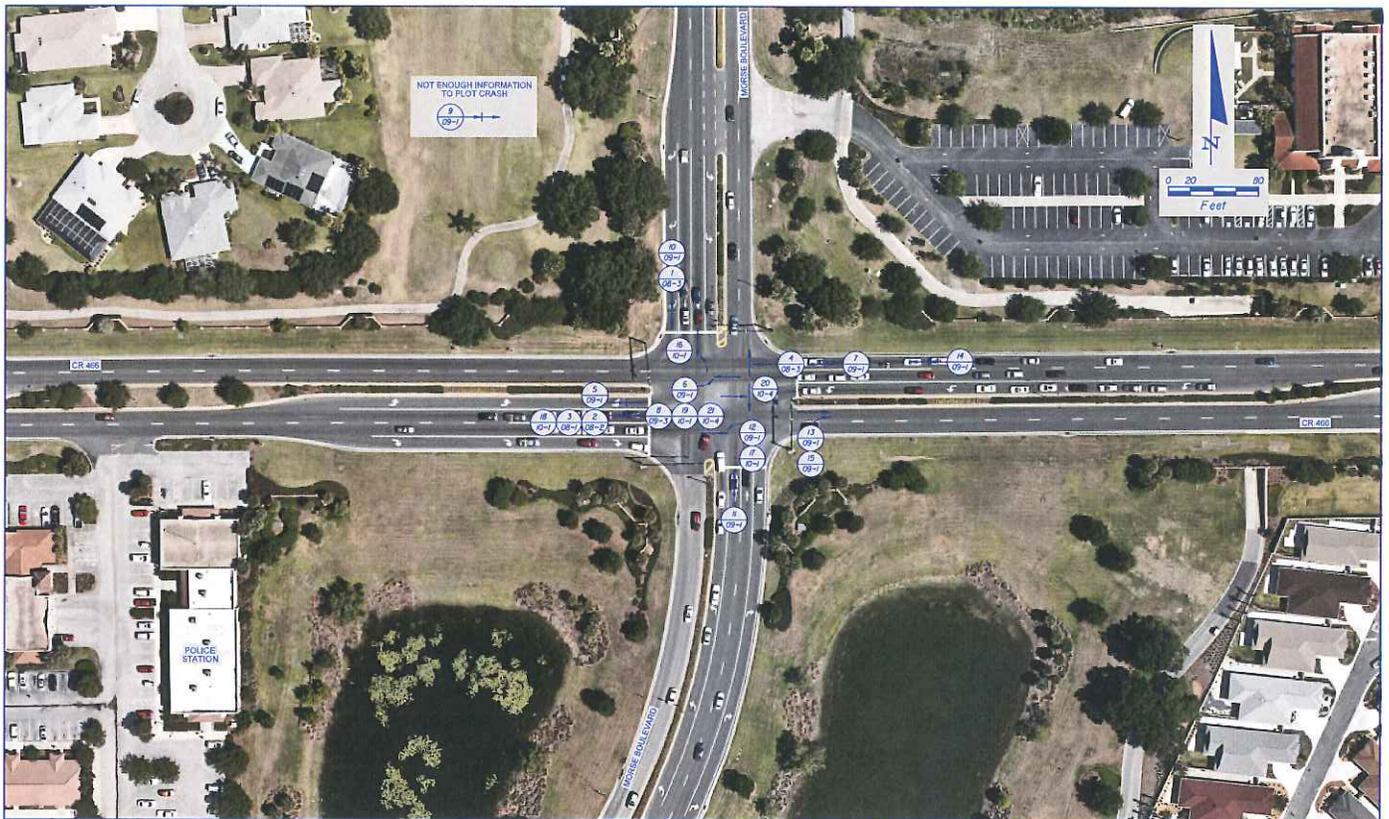
COLLISION DIAGRAM
 DISTRICTWIDE COMMUNITY
 TRAFFIC SAFETY PROGRAM
Faller Davis & Associates, Inc.
 PAGE NO. 12

- Crash reports were provided for CR 466 at Morse Boulevard by the Department for the 37 month period ending December 31, 2010. Twenty-one crashes were reported, which included ten rear end crashes, seven left turn crashes, two angle crashes, and two right turn crashes. These crashes resulted in seven injuries, no fatalities, and an estimated \$79,250 in property damage. Approximately 95 percent of the crashes occurred on a dry roadway surface in daylight lighting conditions.
